Community College

Deep Foundations – Installing Micropiles

PROJECT OVERVIEW

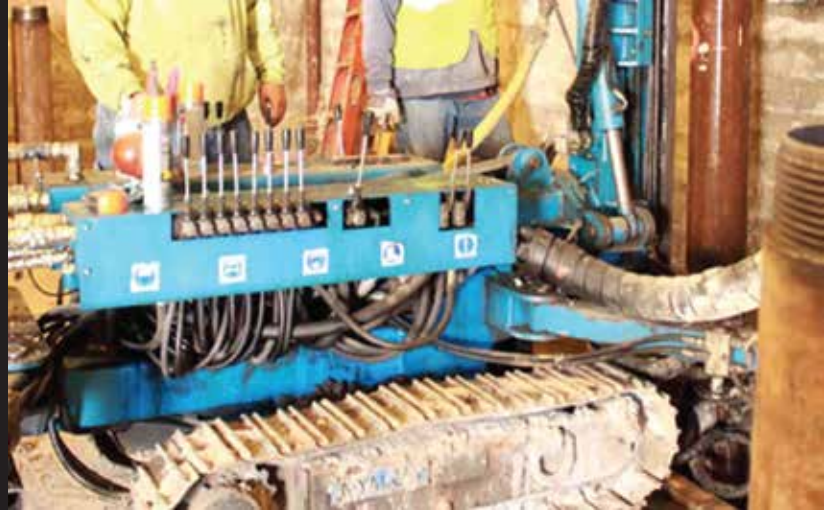
The major issue in construction was the building situated engineered fill began to settle, allowing 4 of the 8 columns to rotate both horizontally and vertically.

Based on the sub-surface conditions, the design requirements, and the urgency of the failed columns, we chose Hollow Bar Micropiles to solve the problem. The piles were installed through the existing column pads and attached to the column pads to provide minimal disturbance to the fill material. Overall, CNC Foundations installed 24 Hollow Bar Micropiles to support the existing columns.

The project was completed in 4 days. The Hollow Bar Micropiles were installed, and the columns were cut and readjusted to sit square on the footing as designed. Working in a low overhead clearance of only 13 feet, we were able to use multiple mast adjustments in installing the Hollow Bar Micropiles saving hours of installation time, and providing the owner considerable cost savings.
