Fitness Center Chicago Suburb Oak Brook

Ground Improvement – Pre-drilled vibratory stone columns & vibratory concrete columns

CNC Foundations installed pre-drilled vibratory stone columns and vibratory concrete columns for a fitness center in the Chicago suburb of Oak Brook, IL.

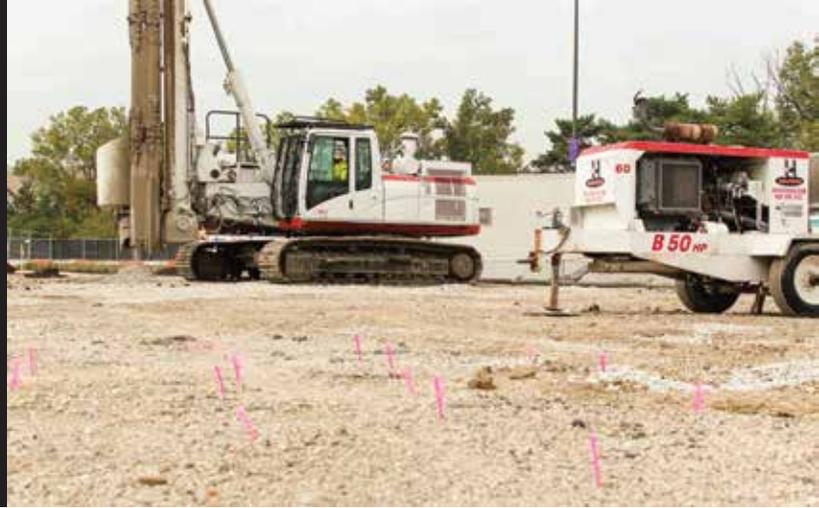
For this job, we completed ground improvement for a future fitness center in the suburbs of Chicago Illinois. CNC Foundations is an industry leader in ground improvement techniques. We provide design-build services for different general contractors and developers. On this site, we are installed vibratory stone columns and vibratory concrete columns.

We utilized a bottom feed vibratory stone column method because of the granular soils that were highly collapsible on this site. Vibratory stone columns can be installed in two different ways.

- Top Feed – the stone is tipped from the surface.
- Bottom Feed – the stone travels to the bottom of the flat via displacement pipe and the pile is built from the bottom up on certain parts of this particular site.

On this site, there were granulars that were compacted fairly stiff at the surface. The solution was to pre-bore the upper 10 feet of these particular piles.

Also on this jobsite were peat and organic soils. Peats and organics will break down over time, thus causing potential settlement in the future. On this building, we also utilized vibratory concrete columns that created a rigid element through those peat and organic layers that will mitigate any potential concerns for settlement in the future.

Vibratory concrete columns are where concrete is pumped from a ready mistrust or batch plant through a displacement pile from the top of the vibratory fly down to the bottom of the vibratory probe. The concrete is then pumped at the base of the pile and it's built-in lifts from the bottom of the pile all the way to the surface.
